Regional School District 13 - Facility Utilization Study

2.4 Summary of the MEP Analysis Report

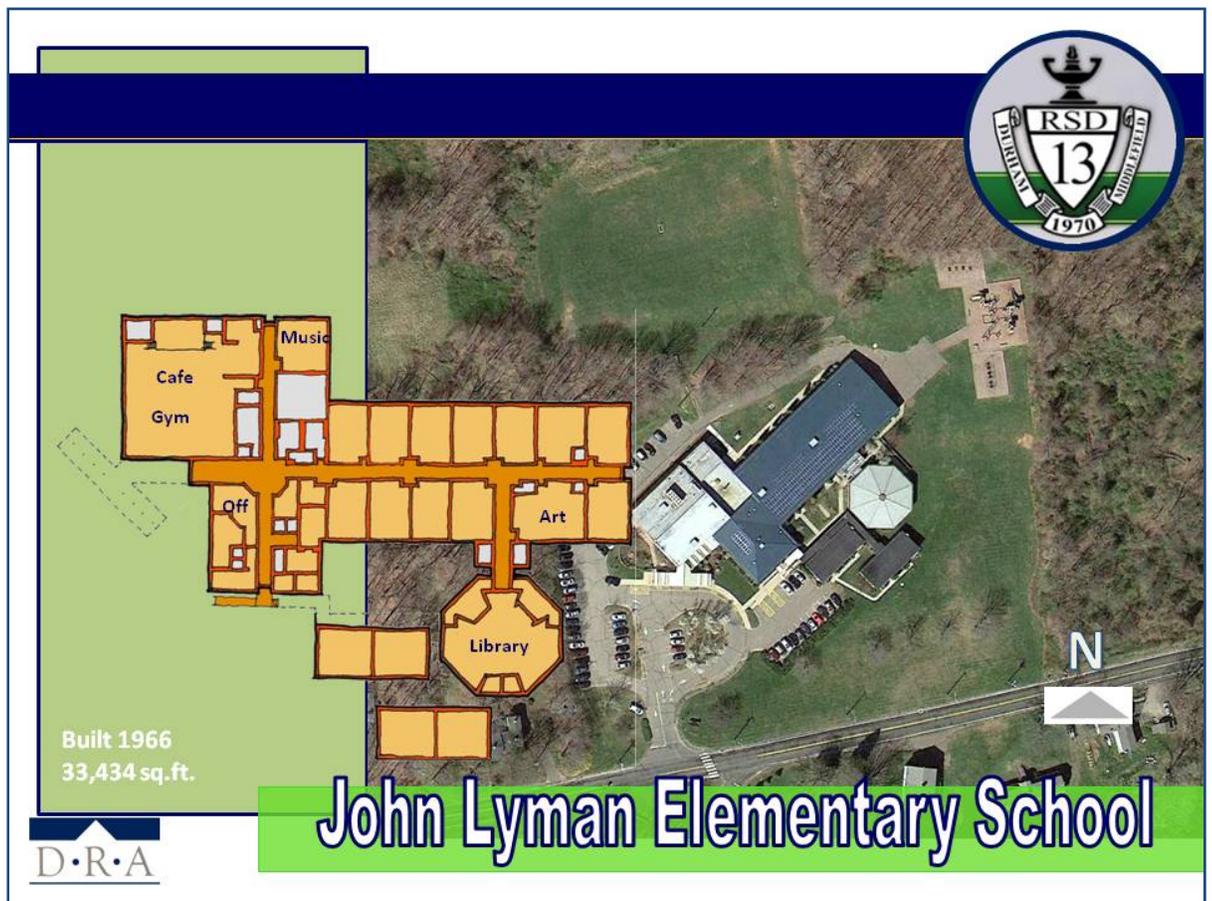
Lyman School sits on a 14-acre site, constructed in 1966 with an addition in 1996; a total of four modular classrooms have been added in 1999 and 2001. The building is 33,434 sq.ft. in size, without modular classrooms.

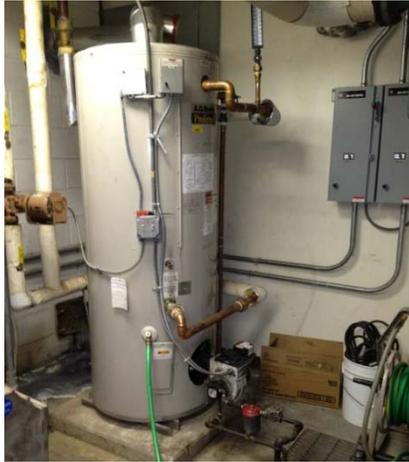
Brewster School's mechanical, electrical, and plumbing systems have served the community well. Many systems are roughly 15-25 years old, with a few more recent

replacements (e.g., the water heater and some site lighting). However, some systems are nearing or past their useful life expectancy: for example, the boilers, heating hot water pumps, administrative air handling system, kitchen hood exhaust system (as well as other exhaust fans), and an inadequate fire protection system; the boilers in particular constitute a code violation. Air flow problems in classrooms create a noise issue, and there is also a need to renovate the problematic roof vent piping near the kitchen, and related systems -- including the air handling units, chiller, ventilators, boiler, and exhaust fans -- will also eventually need

planned replacement. A full-coverage sprinkler system and an emergency generator are needed, and efficiency improvements to some plumbing and electrical systems could result in a reduced carbon footprint and cost savings.

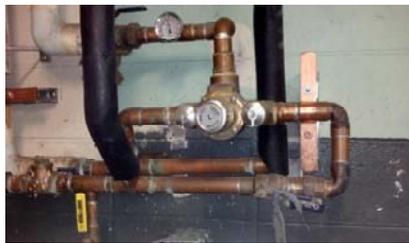
A slightly newer building, Korn School has MEP systems which are mostly about 10-15 years old and generally in good condition. However, some systems are nearing or

past their useful life expectancy: for example, the administrative air handling system and the kitchen hood exhaust system. Other systems are showing wear -- e.g., leaks are developing in the plumbing hydro-tank -- and parts issues also require attention (the need for kitchen grease interceptors, certain plumbing valves, etc.). Related systems including

the air handling units, chiller, ventilators, boiler, and exhaust fans, will also eventually need planned replacement. A full-coverage sprinkler system and an emergency generator are needed, and efficiency improvements to some plumbing and electrical systems could result in a reduced carbon footprint and cost savings.
